L.2.3.4 | Production et adaptation des métadonnées des sites démonstrateurs

Spécifications relatives au site Engeland 1

RUE ENGELAND, UCCLE, 1180, BELGIUM

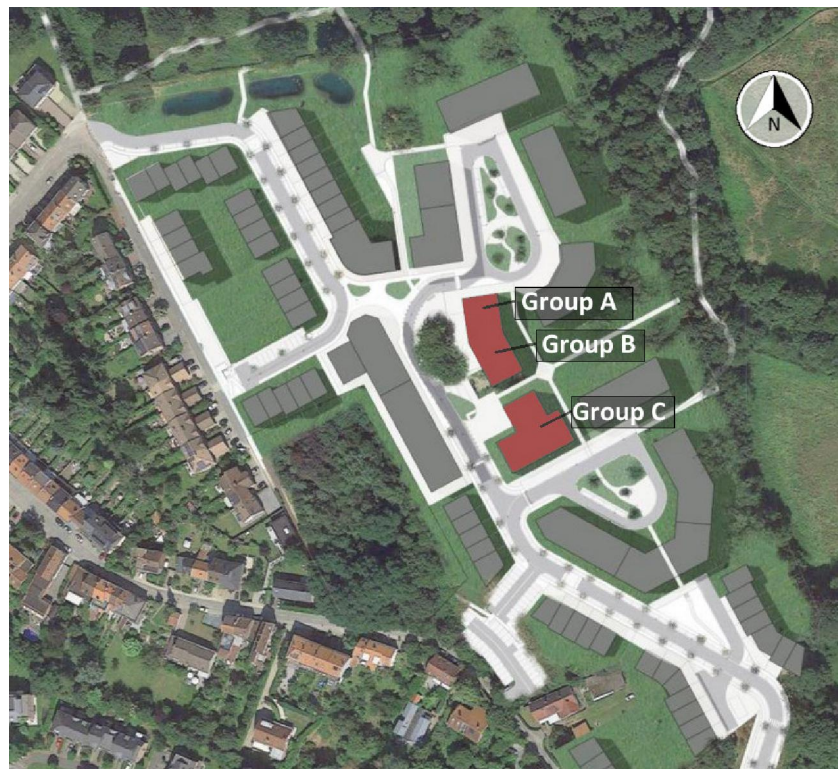
Figure 1 : Site Engeland

The experiment was undertaken in a building complex in the street Engeland. The site is located in Uccle, at the South of Brussels, in Belgium. The construction, accomplished by "*Jacques Delens s.a.*" [JD], is a part of a complex of 238 dwellings (houses and apartments). The measures have been taken in two apartment of the group C, illustrated in the following figures.

The apartments considered for the study are facing South-West and are located on the first and second floor. At the period of the test, the building facing the units was not yet constructed.

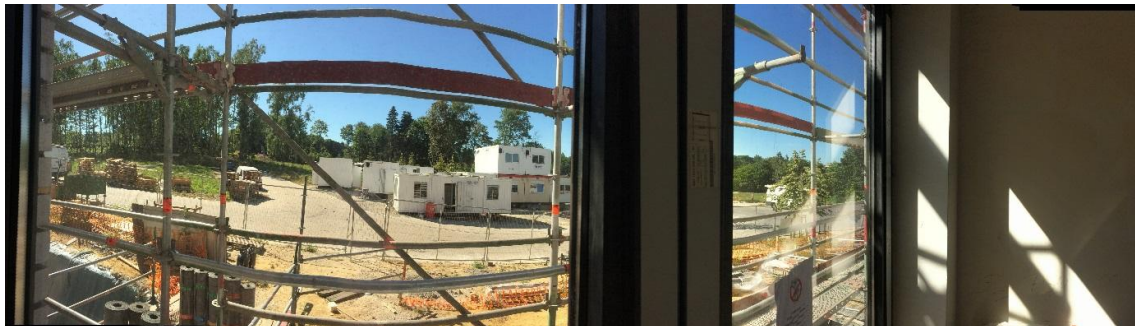
Figure 10 : Panoramic view from C.1.4 apartment, Unit AU

The apartments are located in Uccle, at the South of Brussels in Belgium. The land plot is in project to be constructed with more than 200 dwellings. But at the time of the tests, the land plot was still not constructed in front of the units, which limits the effect of mask. However, a scaffold was placed in front of the windows, as shown on Figure 10. The latitude of the buildings is 50.783N and the longitude is 4.345E. The elevation above the sea level is approximately 77m. The data were measured in local summer time, i.e. in Central European Summer Time (UTC/GMT+2h). They were averaged every 10 minutes and recorded at the end of those ten minutes intervals.

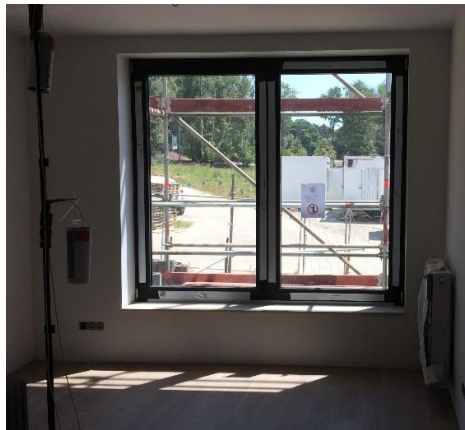
Figure 19 : Internal view in the bedroom unit B, effect of the shade screen

During the experiment, a scaffold was present in front of the windows. It has an influence on the solar heat gains. The placement of pyranometers in front of the window, inside the units BU and BI allows to assess the heat gains despite of these shade screen. Beyond this scaffold, there were no other masks affecting the solar gains as the site was clear in front of the building of the experiment.

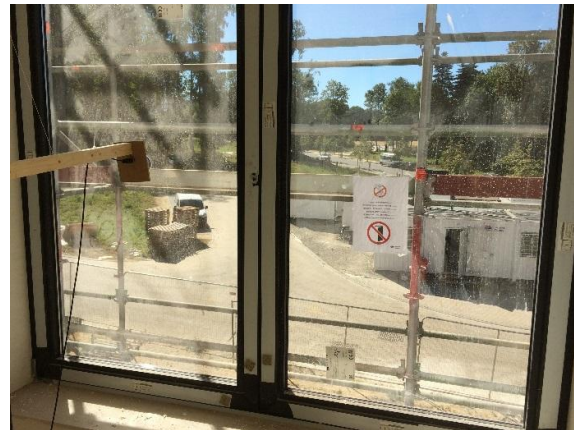
Figure 20 : View of the scaffold, Unit BI

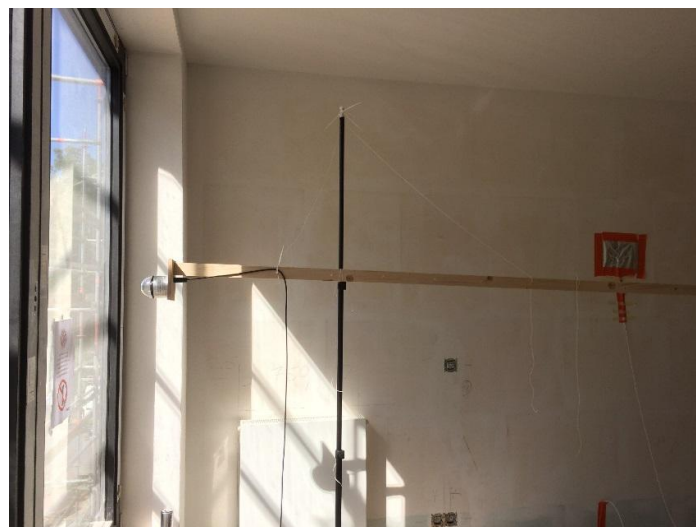
Figure 21: Pyranometer in front of the window in unit BU

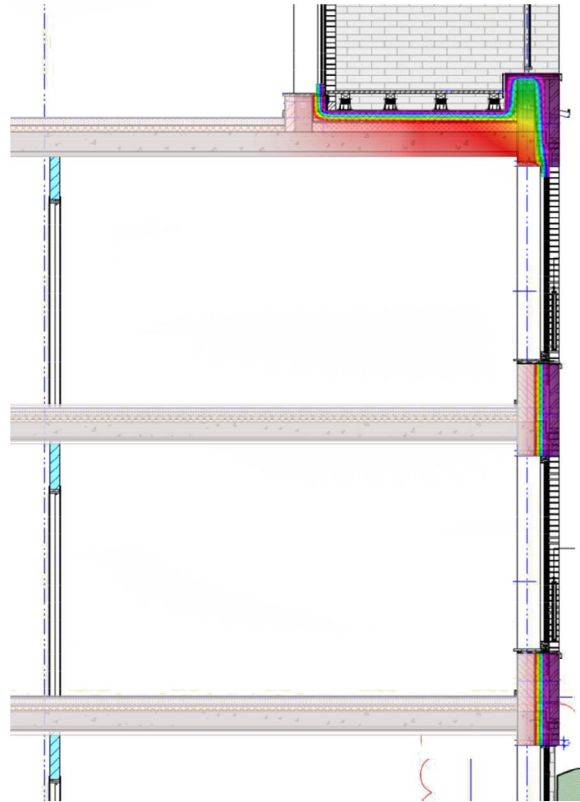
Figure 22 : Section drawing of the main thermal bridges

The thermal bridges Ψ values were assessed via the THERM software. The thermal loss calculation is performed on the basis of internal wall dimensions. The main thermal bridges are illustrated in Figure 22.

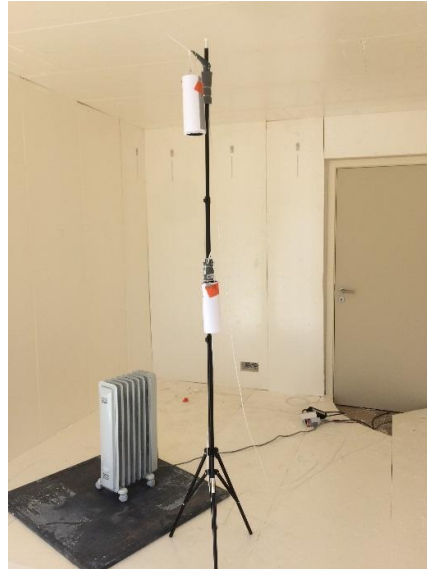
Co-heating was performed with an electric radiator, with the configuration shown in Figure 27. The power of the radiator is directly controlled by the indoor temperature measured by the temperature sensor located at the center of the room.

Figure 27 : Electric radiator in the insulated unit (AI)

The goal of the experiment is to perform side by side experiments with a time duration of 9 days. The units AI and AU were heated while units BI and BU were in floating temperature mode. The heating set point was 33°C.

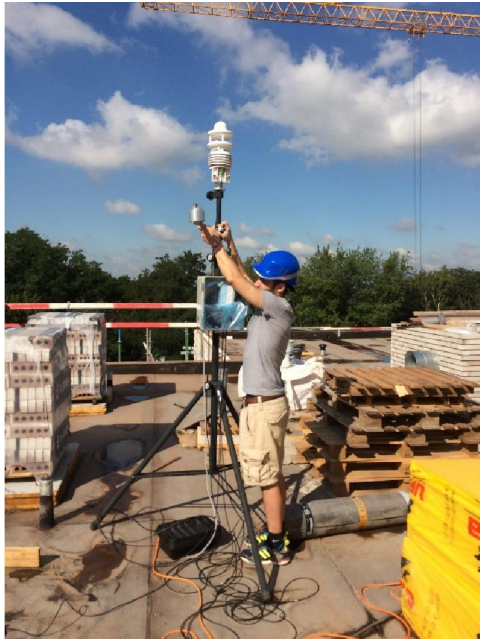
The weather data during the experiment were collected on site with a weather station located on roof. This station collected the data of wind speed and direction (at approximately 10 m above the ground), atmospheric pressure, air temperature, relative humidity, rain fall and intensity and global solar radiation on a horizontal plane. The data were recorded as average values every 10 minutes. One supplementary station was placed on the roof, just next to the first weather station, collecting global solar radiation on a vertical plane at the same frequency. Two other pyranometers were placed in the BU and BI units, just behind the windows, to collect global solar radiation entering the units.

Figure 28 : Weather station on the roof

A weather station located on the roof collected:

- Solar radiation data: direct and global on a horizontal plane + calculation of the difference for diffuse radiation in W/m^2 ;
- Wind: speed in m/s / orientation and maximal speed in degree from North ;
- Temperature in $^{\circ}C$;
- Relative humidity in % ;
- Atmospheric pressure in Pa;

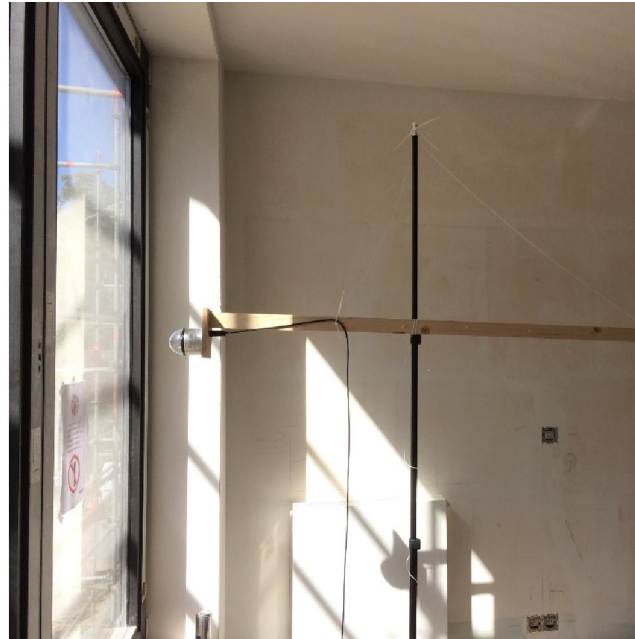
Figure 29 : Pyranometer in front of the window in unit BU

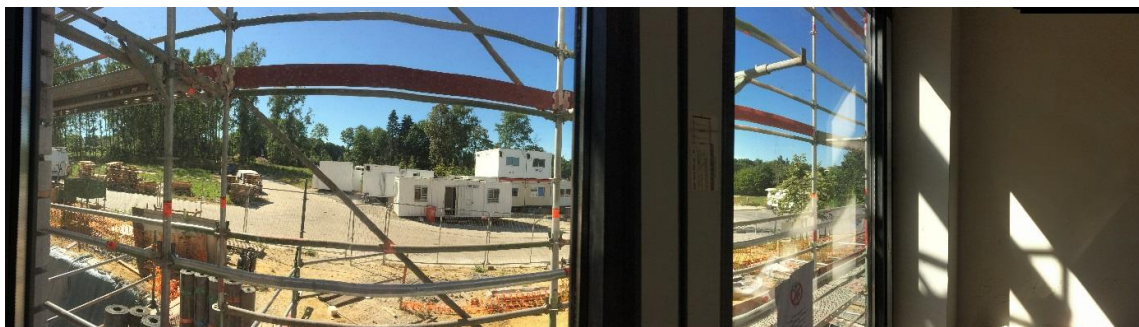
Figure 30: Panoramic view toward the window of unit AU

The ground reflectivity wasn't measured. The scaffold interfere surely with those data. In front of the building, the main ground surfaces are sand, roads and the construction lodges.

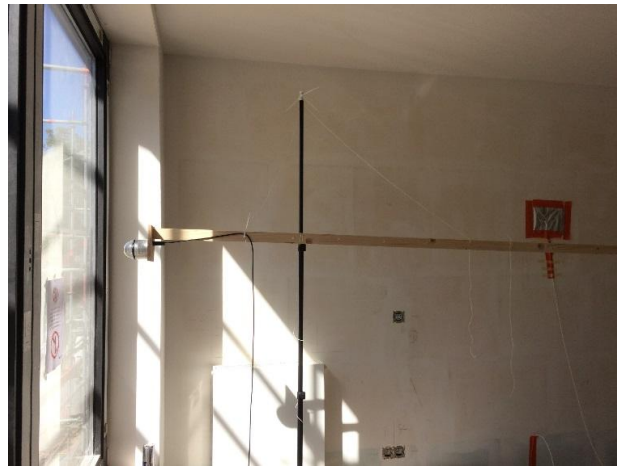
Figure 34 : Pyranometer in unit BU

- 9 Temperature sensors per unit: 5 sensors located on the ceiling, floor and party walls either on the wall surfaces in uninsulated units, or at the interface between walls and insulation panels in insulated units, 2 air temperature sensors in the tested unit (in the center of the room, one high and the other at 1m20), 1 temperature sensor in the adjacent Northern zone in the same apartment.
- 1 pyranometer in each unit B, named BIRFM and BURFM. It was located in front of the windows as shown in Figure 34. It allows to collect the total amount of solar irradiance entering the units.
- Co-heating consumptions were monitored in kWh. NOTE: The recorded powers are computed from the differences of the recorded consumptions. As data were recorded with a 10 minutes interval, recorded power must be multiplied by 6 to be expressed in Watt.
